ALEXA 35 SUP 1.3.0

Software Update Package (SUP) 1.3.0

RELEASE NOTES

July 12, 2024

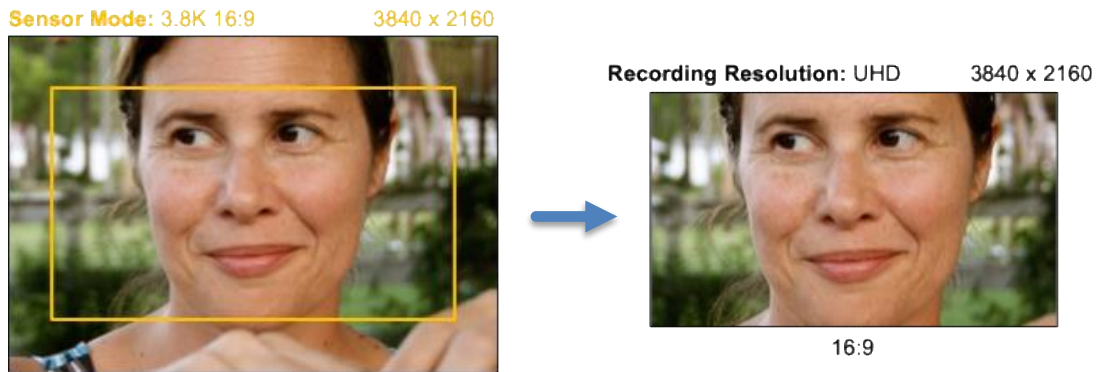
ProRes 3.8K 16:9

Previously only available in ARRIRAW, this popular recording format is for projects using spherical lenses for a 16:9 deliverable with a 4K UHD resolution (3840 x 2160). This format is useful when you want to achieve the lowest possible data rate in ProRes while still fulfilling 4K UHD mandates. In addition, this format has a smaller sensor area than sensor modes 4.6K 3:2 Open Gate, 4.6K 16:9 or 4K 16:9, which ensures that the illumination circle of most Super 35 format lenses covers the format.

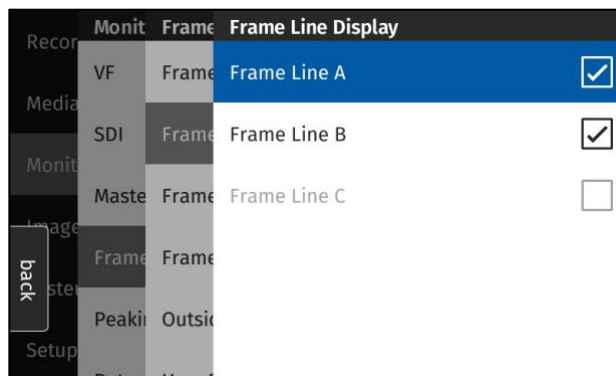
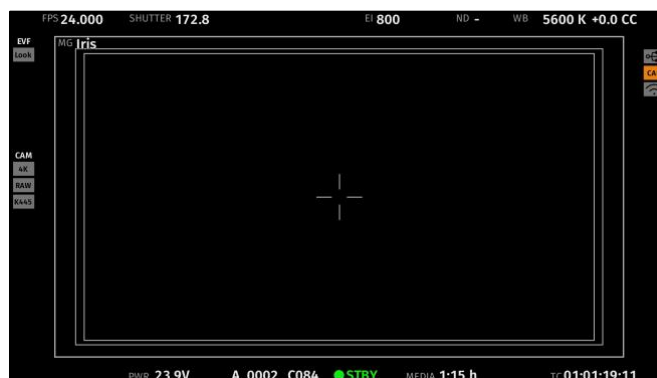
EBU R095 Frame Line

For 16:9 sensor modes a EBU R095 frame line has been added to the cameras frame line default list. In the xml file the two safe areas are included as frame line A and frame line B. In a Multicam environment it can be freely chosen which safe area is displayed (A, B, A+B) via the frame line display setting.

The action safe area is 3.5% and the graphics safe area is 5%, at the top, bottom and lateral part of the image.
